Hypertensive Crisis During Norepinephrine Syringe Exchange: A Case Report

A 67-year critically ill patient suffered from a hypertensive crisis (200 mm Hg) because of a norepinephrine overdose. The overdose occurred when the clinician exchanged an almost-empty syringe and the syringe pump repeatedly reported an error. We hypothesized that an object between the plunger and the syringe driver may have caused the exertion of too much force on the syringe. Testing this hypothesis in vitro showed significant peak dosing errors (up to +572%) but moderate overdose (0.07 mL, +225%) if a clamp was used on the intravenous infusion line and a large overdose (0.8 mL, +2700%) if no clamp was used. Clamping and awareness are advised. (A&A Case Reports. 2016;8:178–81.)

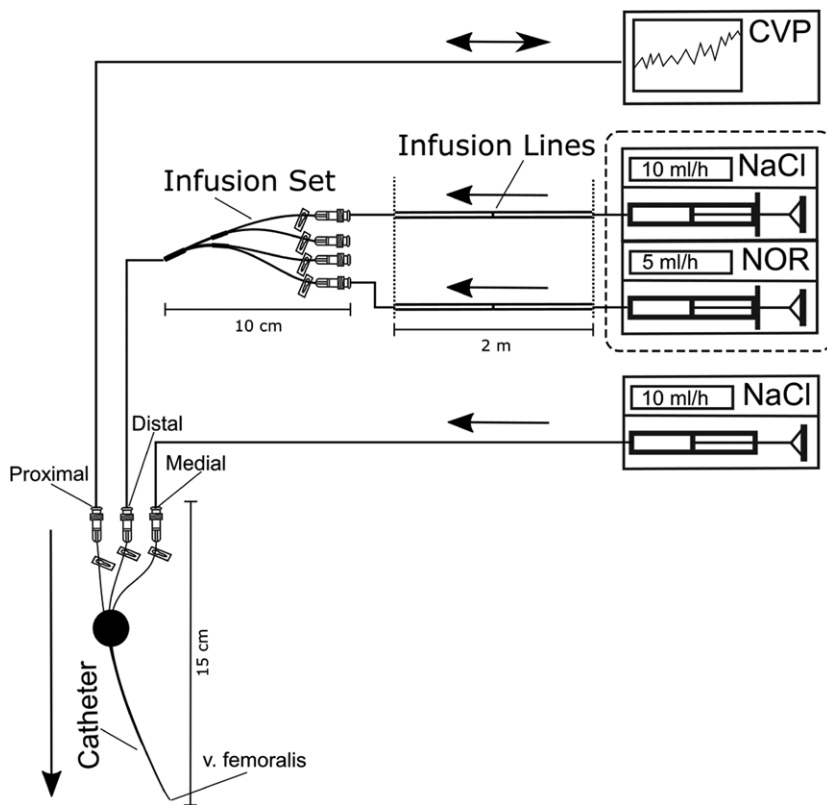
Figure 1. Infusion setup. Within the square area indicated by the dotted lines are the NaCl and norepinephrine (NOR) pumps. Only these pumps were involved in the incident. The drugs from both these pumps were joined with an infusion set and subsequently administered to the patient with the distal lumen of a triple-lumen catheter. An additional central venous pressure (CVP) measurement and NaCl flush, respectively, connected to the proximal and medial lumen of the catheter are indicated as well. The flow rates are denoted in the schematic representations of the infusion pumps. Also indicated are the flow rates during the incident; these were acquired from interviewing the nurse and, in case of the norepinephrine pump, from reading out the pump log files.

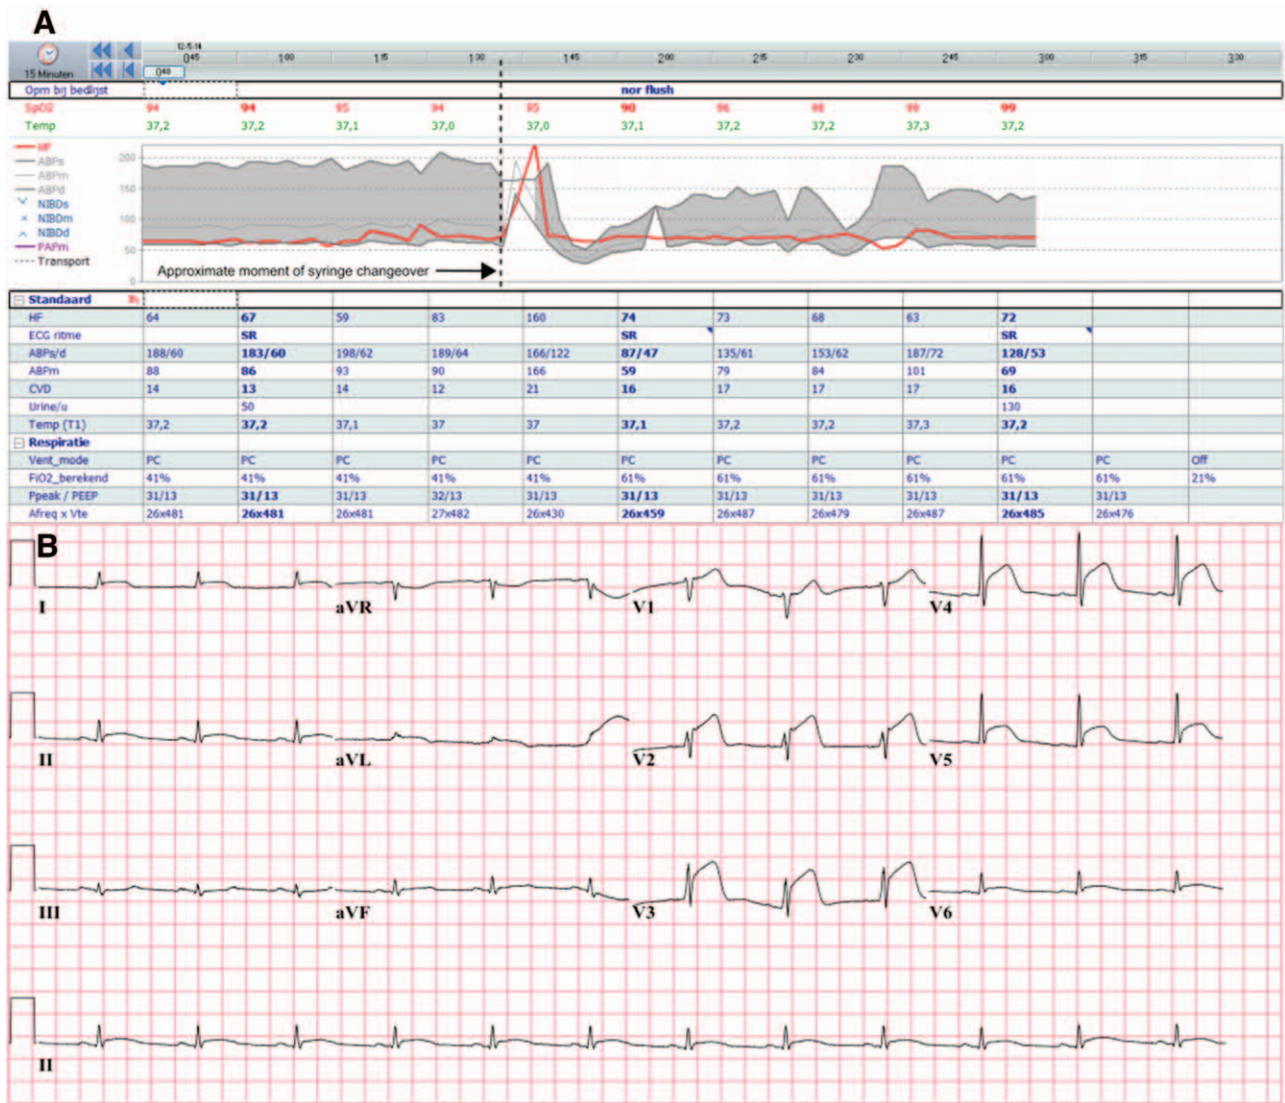
When norepinephrine was administered, the syringe pump produced an alert indicating that the syringe would be empty within 10 minutes. On the mounting of the new syringe, the pump signaled "repeat syringe exchange." The full syringe was removed from the pump and remounted. The pump gave the same error message again, 3 times in a row. At the fourth attempt, the syringe was mounted inside a different pump, which did not signal an error. After restart of the infusion, the patient instantly underwent a period of severe hypertension (mean arterial pressure 200 mm Hg, see Figure 2A) lasting for several minutes, strongly suggestive of an inadvertent overdose of norepinephrine. To lower the mean arterial pressure, labetalol was administered. After stabilization, electrocardiogram values were indicative for a myocardial infarction (Figure 2B), and ultrasound confirmed that the anterior heart wall movement was impaired.

Figure 2. A, Vital signs during the incident in the night from May 11, 2014, to May 12, 2014, at approximately 01:50. Mean arterial blood pressure (MABP) > 200 mm Hg, diastole pressure 150 mm Hg, systole pressure 100 mm Hg, heart rate (HR) > 200 bpm. B, Electrocardiogram (ECG) values approximately 10 minutes after the incident. Clearly visible ST-elevation in nodes I, II, and III is indicative of myocardial infarction directly after the incident. Heart rate normalized quickly (approximately 70 bpm).

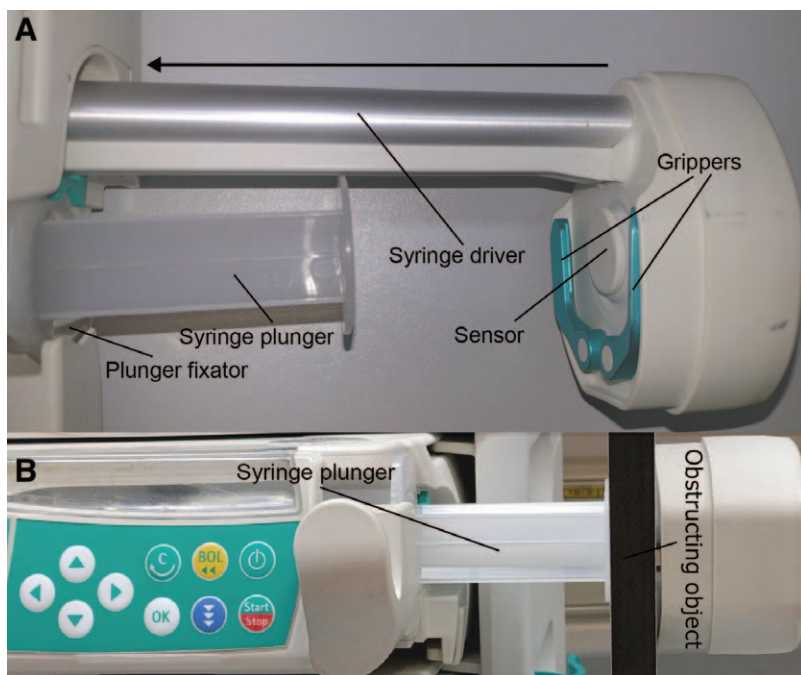
After the incident, the pump was inspected by a maintenance engineer, who found no defects, erroneous flow rate settings, or other abnormalities. Our investigation, however, showed that the pump gave the reported error message if an object, such as intravenous tubing curled up next to the gripper, became interposed between the syringe plunger and the syringe driver. In that case, the syringe driver exerts too much force on the syringe plunger (Figure 3). In our hypothesis, this may have occurred repeatedly and caused pressure build up in the syringe, which in turn caused too much flow and thus dosing errors upon release of the clamp, or immediately if no clamp was used.

syringe driver obstruction in a systematic manner, the grippers used to grab the plunger were obstructed deliberately with a solid “obstructing object” between the syringe driver and the plunger (Figure 3B). Consequently, the pump signaled the error message and asked the user to repeat the syringe exchange; this procedure was repeated 3 times. Next, the obstructing object was removed, the syringe was mounted correctly, and the clamp was released. The experiment was repeated without the placement of a clamp. Finally, a nominal syringe exchange, that is, a syringe exchange without any obstruction or errors, was investigated.

Figure 3. Mechanism of the syringe driver of the syringe pump in the laboratory, identical to the pumps described in the case report. A, After the syringe is placed, the syringe plunger is fixated with a plunger fixator knife. Next, the syringe driver moves toward the syringe plunger until the sensors registers the plunger. After this, the grippers grab the syringe plunger, and the plunger fixator is retracted. The grippers protrude somewhat over the sensor. B, Obstructing object allowing the syringe driver to exert force on the syringe plunger while the thickness of the grippers prevents the sensor to signal the syringe driver to halt. The syringe driver eventually does retract; however, the force exerted is large enough to cause dosing errors.

or some other object; it is therefore important that clinicians are aware of these phenomena. Norepinephrine overdose because of the technical glitch investigated in this study is deemed plausible but avoidable. Technical innovations such as less protruding grippers or reducing the force exerted by the syringe driver might reduce or eliminate the effect of the described malfunction. Clamping the line is, however, essential. Clinicians who were treating the patient in the described case considered the possibility that line was not fully clamped. Failing to clamp the infusion line may produce an overdose for at least 2 reasons. First, free flow may occur. In such a case, the higher situated syringe empties into the patient because gravity “pulls” the medication toward the patient.⁸ Second, as the results showed, an obstructed syringe driver may produce an overdose of almost 1 mL if the infusion line is not clamped, despite the fact that a blade-like fixator is placed inside the plunger by the pump.

It is plausible that the norepinephrine overdose was because of the potential malfunction, where the syringe driver is obstructed. Partial human error is still a likely alternative explanation, especially because clamping of the infusion was uncertain so that free flow may have occurred. Moreover, if the line is not clamped and the pump is obstructed, the malfunction may produce a significant overdose of almost 1 mL. Therefore, a combination of an obstructing object between the syringe driver and plunger and an unclamped line explains both the severity of the overdose and the error message of the pump described in the case report. This study therefore reinforces the importance of using a clamp during the exchange procedure. In addition, removing the syringe from the pump each time the pump fails to start decreases the risks. ■■
