# Experimental repair technique for glass defects of glass-glass photovoltaic modules – A techno-economic analysis

Mathijs P.M. Tas<sup>a,b,c</sup>, Wilfried G.J.H.M. van Sark<sup>a,\*</sup>

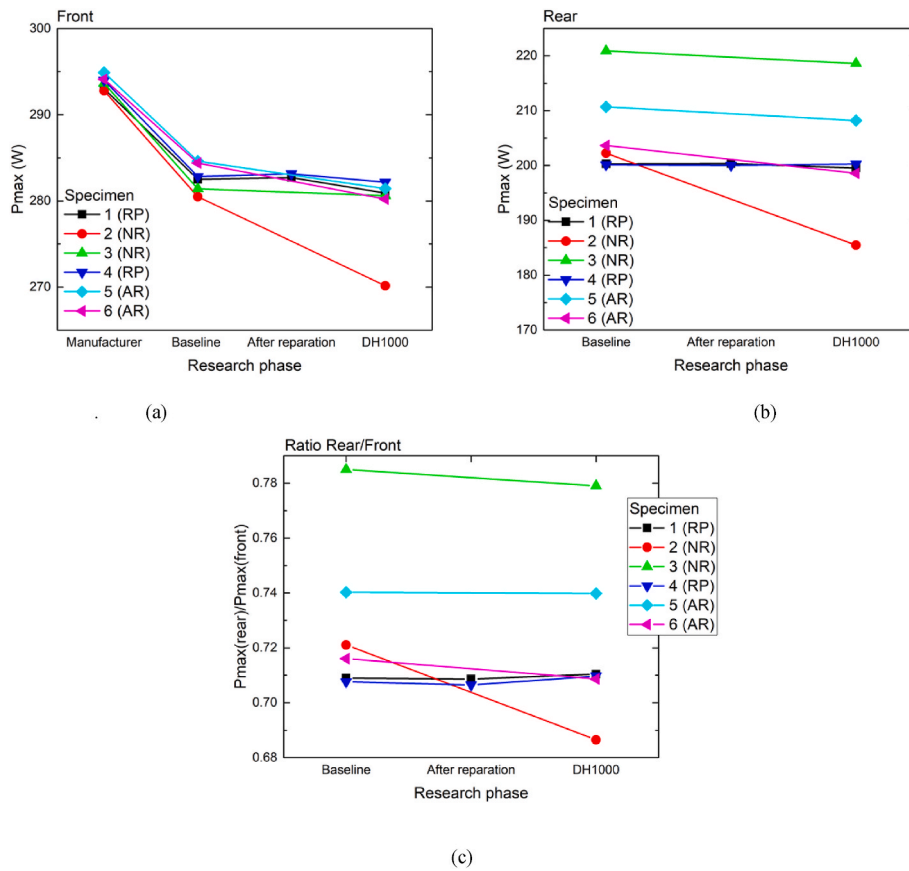
Fig. 2. Measured maximum power  $P_{max}$  (W) of the various PV modulea at each phase of the research phase, (a) front side, (b) rear side, and (c) power ratio of rear to front side. The black and dark blue lines (specimens 1 and 4), represent the repaired PV modules. The read and green lines (specimen 2 and 3), the non-repaired PV modules, and the light blue and purple lines (specimen 5 and 6), are the as-received (reference) PV modules.

module by the DH test. The EL images confirm the degradation at specimen 2 and denote significant PV cell degradation (see Appendix C). However, specimen 2 did not register any visible indications for water infiltration. Research by Yang et al. [64] identified that POE encapsulant has a low WVTR at frameless double-glass PV modules, this could have constrained the visible water ingress. The other three specimen (specimen 3, 5 and 6) did not register any visible change. Degradation is inherent to DH testing, the EL images from these three specimen showed gradual change in grayscale, indicating an uniform degradation of the PV cells.
