EVALUATING 5-YEARS PERFORMANCE MONITORING OF 1 MW BUILDING INTEGRATED PV PROJECT IN NIEUWLAND, AMERSFOORT, THE NETHERLANDS

Keywords: PV system; performance; monitoring

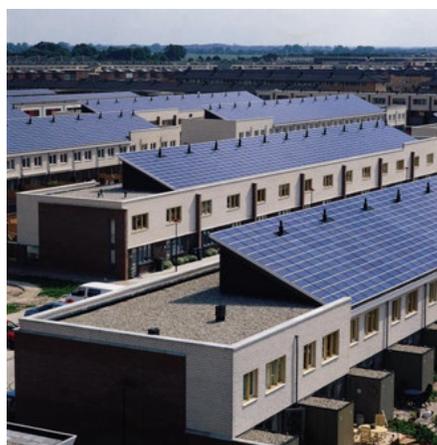
Figure 1: Systems in Section K1 [5]

architectural and system designs in each of the sectors. Figure 1 shows an overview picture of one of the sectors. The systems have different architectural designs, installed power ranging from 0.8 to 4.4 kWp per house and tilt angles ranging from 20 to 90 degrees. In Table 1 the number of systems in different sections, their sizes and tilt angles are listed. Section O consists of school buildings, while all the other sections listed consist of family houses. Almost all of these systems are monitored with the Eclipse monitoring device [5]. Installations on other utility buildings are not shown. The systems in the O and K sectors are owned by Eneco, while in the N sectors the house owners own the systems.

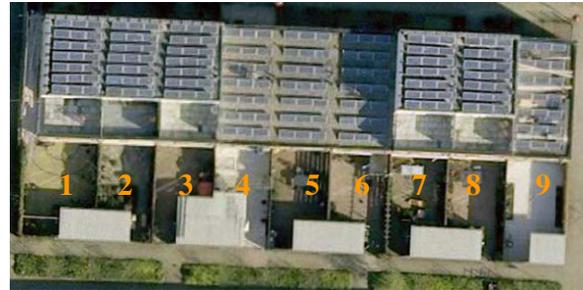
Figure 9: Extra floors in Section N2, image from Google Earth.

The systems on the houses in sector N2 consist of seven rows of three modules. Originally these rows were placed some distance apart as can be seen in the middle three houses shown in Figure 9. Also in this sector the PR graphic plots and PR distribution table showed the existence of defects and/or other causes for a low PR. Here the comparison of old aerial photos with Google Earth maps showed clearly the main cause. An extra floor was added for several houses. The PV systems have been relocated on this added roof, of which the area is smaller than the original roof area: increased shading is the result. Also the higher roofs shade the lower adjacent roofs significantly as can be seen in the photograph for the situation in the morning. The result can be found in the measurement data.
