Hot wire CVD deposition of nanocrystalline silicon solar cells on rough substrates

Hongbo Li, Karine H.M. van der Werf, Jatin K. Rath, Ruud E.I. Schropp

To appear in: *Thin Solid Films*

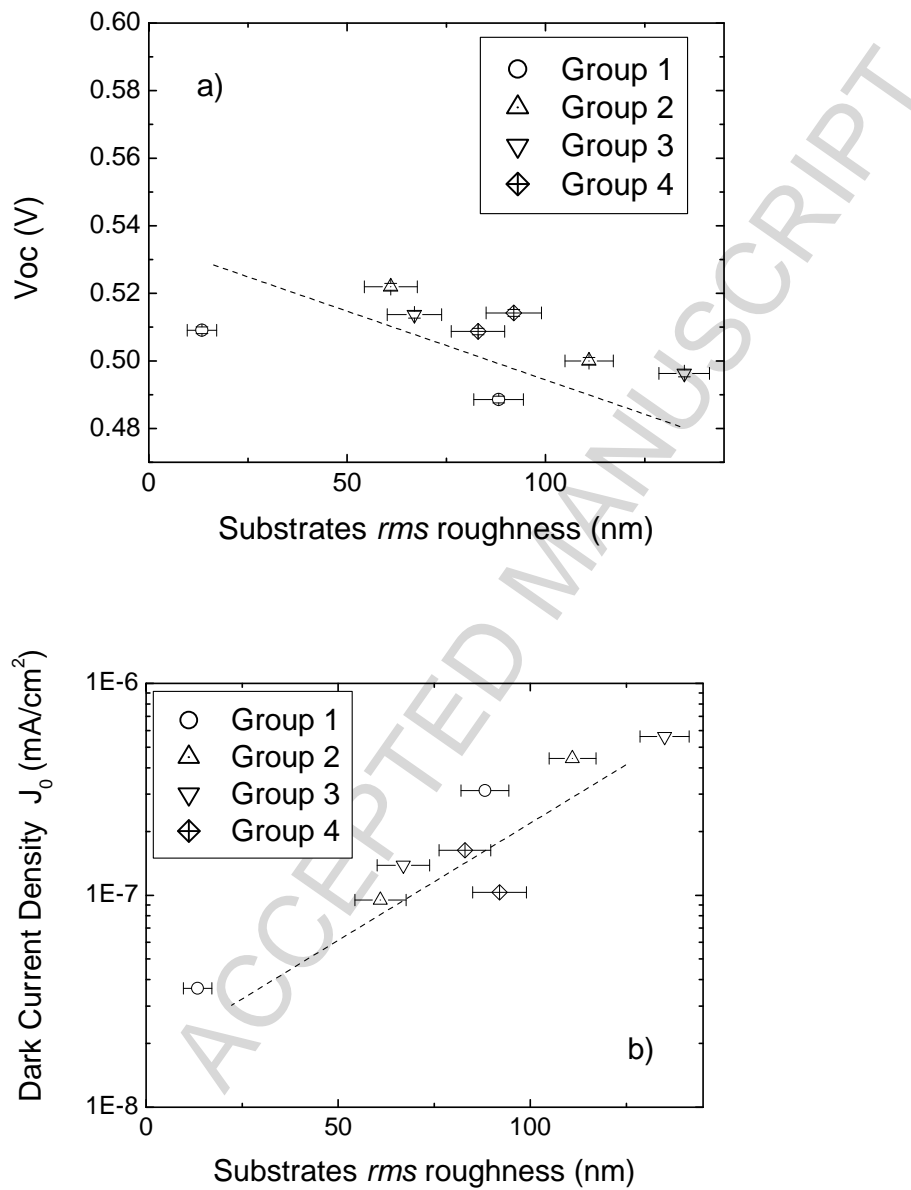
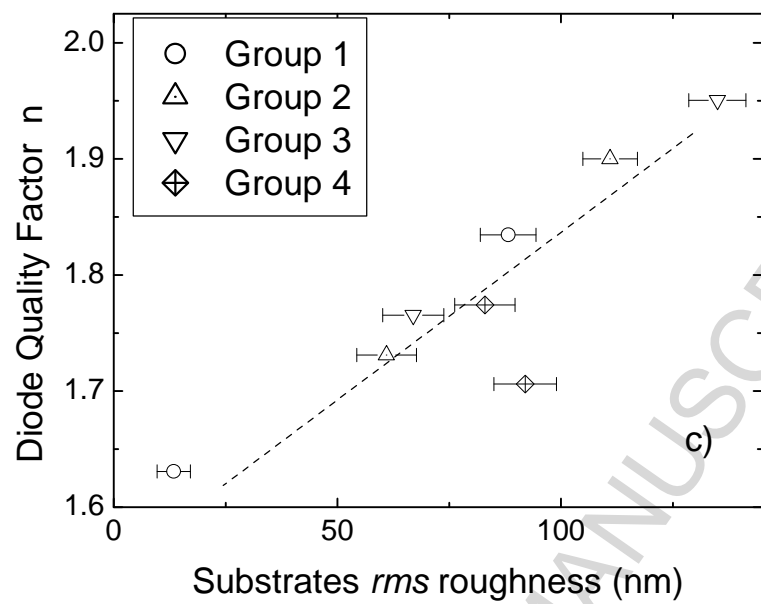
Fig. 2 Dependence of solar cell *J-V* characteristics (V_{oc} , J_0 and n) on substrate surface *rms* roughness.

thin ZnO layer) used for the solar cell deposition. Data points shown in this figure are grouped according to Si deposition runs. Each deposition contains a group of two substrates with different surface roughness. By studying the difference between samples in each group, we can eliminate any run to run difference of Si deposition. The *rms* value of Ag surface varies from ~10 nm to around ~130 nm, with an average lateral feature size ranging from 0.5 μm to ~ 3 μm (**Fig. 1**). For the solar cell series deposited on such substrates under exactly the same conditions, the AM1.5 open circuit voltage (V_{oc}) shows a consistent trend with the *rms* values, as well as the diode quality factor (n) and reverse saturation current density (J_0) (**Fig. 2**).

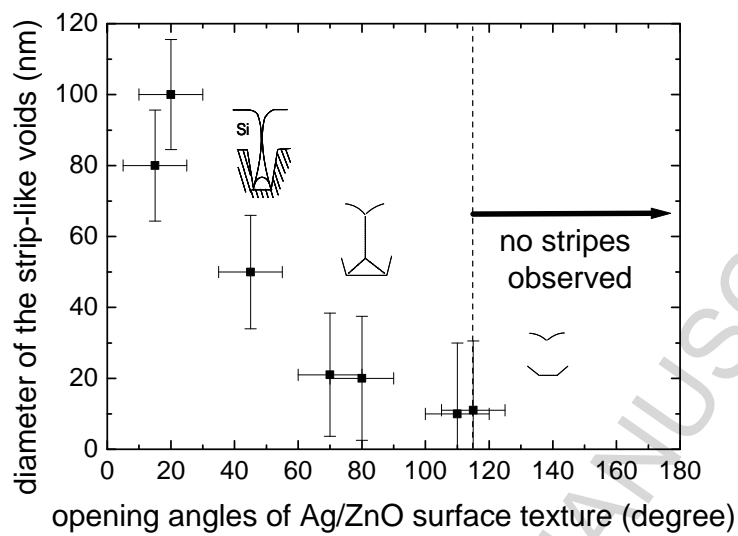
Fig. 4a

Fig. 4 a) Correlation between the opening angle of the Ag/ZnO surface texture and the diameter of the microvoids (white stripes) determined from the TEM images of the n-i-p samples. b) Correlation of the area ratio of voids and substrate, v , and substrate surface *rms* roughness.

In **Fig. 7** we show another possible explanation for the formation of such voids. This is based on the diagrams shown in **Fig. 4a**. Assuming that Si develops layer by layer on top of the surface of the valley, the local films will grow freely until the layer growth fronts from different plates meet. As soon as they meet, there will be stress created in the silicon network. Due to the high density of atomic hydrogen present during the CVD process, the strained Si-Si bonds may be etched away, resulting in regions with a low density of silicon atoms - a void is therefore formed in that region, (the solid arrows shown in **Fig. 7** indicate the layer growth direction; the region encircled with a dashed line: strained atoms that can be easily etched away by H). As long as the layer continues to grow in the same direction, stresses are constantly formed near the corner of the layer growth front. Therefore, the voids will continue to develop along the layer growth direction.

We note that the angular threshold (110°) as marked in the **Fig. 4a** can be related to the material growth technique and conditions. For the deposition involving plasma CVD, the

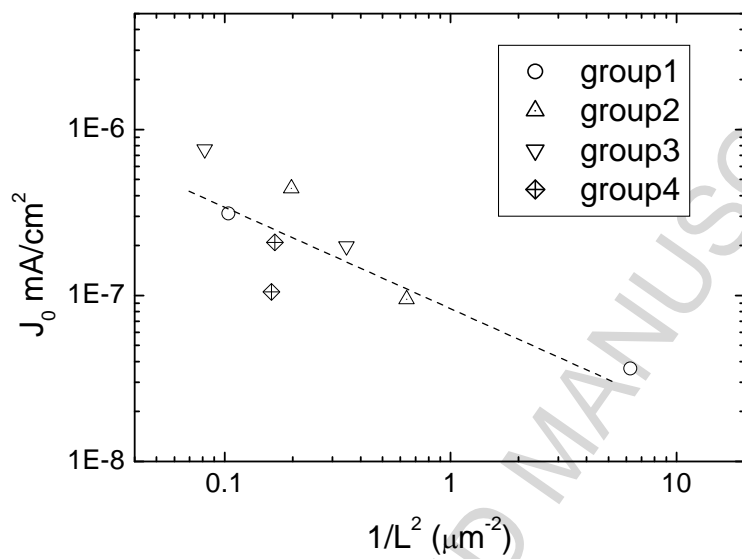
Fig. 5 Correlation of solar cell dark *J-V* characteristics (J_0 and n) on $(1/L)^2$, where L is the lateral feature size of the substrate surface.

As suggested in references [5, 6], the amount of decrease in solar cell dark J - V performance may be correlated with the density of voids (cracks) in the *i*-layer, such as that shown in **Fig. 3c** and **Fig. 3d**. The rougher the substrate is, the higher the density of these voids might be, and therefore the higher the solar cell J_0 and n values are. If we assume that the mechanism of J - V deterioration or, in simpler words, the appearance of voids is the same for samples made on substrate with various roughness (various *rms* values), we might be able to correlate J_0 and n values with the density of such voids. A possible description of void density is $(1/L)^2$, where L is the average lateral feature size of the substrate surface estimated from the substrate AFM images. **Fig. 5a** and **Fig. 5b** show the dependence of J_0 and n on the value of $(1/L)^2$. Surprisingly, in these

figures we do not observe decreases of J_0 and n with the decrease of $(1/L)^2$. Instead, they clearly increase. This suggests that the assumptions used above are not valid. Namely, either the void density is not correlated with $(1/L)^2$ or the appearance of such voids are not the same for samples made on substrates with different roughness. When we look at the AFM images (not shown) of these substrates, we could see that the substrate roughness generally increases with increasing L (**Fig. 1**), which suggests that the Ag poly-crystalline grains grow larger in both lateral and vertical directions. This type of Ag growth most possibly results in different appearance of the microvalley formed between Ag poly-crystals. From the XTEM images of substrates with different *rms* values (such as shown in **Fig. 3a-d**), we can indeed see large differences in the appearance of substrate surface morphology. From **Fig. 3a** to **3d**, the estimated opening angle of the microvalleys shown in these images are $\sim 180^\circ$, $\sim 120^\circ$, $\sim 89^\circ$ and $\sim 30^\circ$, correlated to substrate *rms* roughness values of $\sim 4\text{nm}$, $\sim 66\text{nm}$, $\sim 96\text{ nm}$ and $\sim 133\text{ nm}$ respectively. Starting from the sample shown in **Fig. 3c**, stripe-like voids can often be observed in the XTEM images, the density of which increases with increasing substrate surface *rms* roughness, so does the width of the voids estimated from the XTEM images.

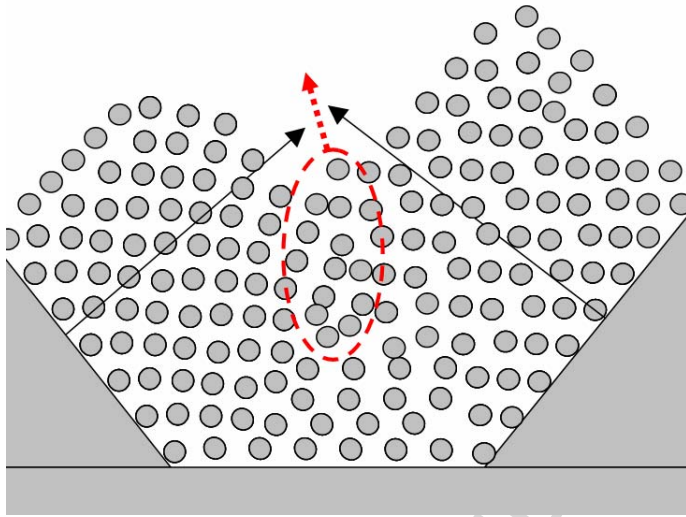
Fig. 7 Diagram of a possible mechanism for the formation of cracks, where H etching on strained Si-Si bond is depicted.
