Restoration of annular zonal isolation using localized casing expansion (LCE) technology: Treatment of near-horizontal test sections containing a free-water channel

K. Beltrán-Jiménez^a, H.J. Skadsem^{b,a,*}, J.K. Sunde^a, D. Gardner^a, T.K.T. Wolterbeek^c, E.K. Cornelissen^d, W.J.G. Keultjes^d

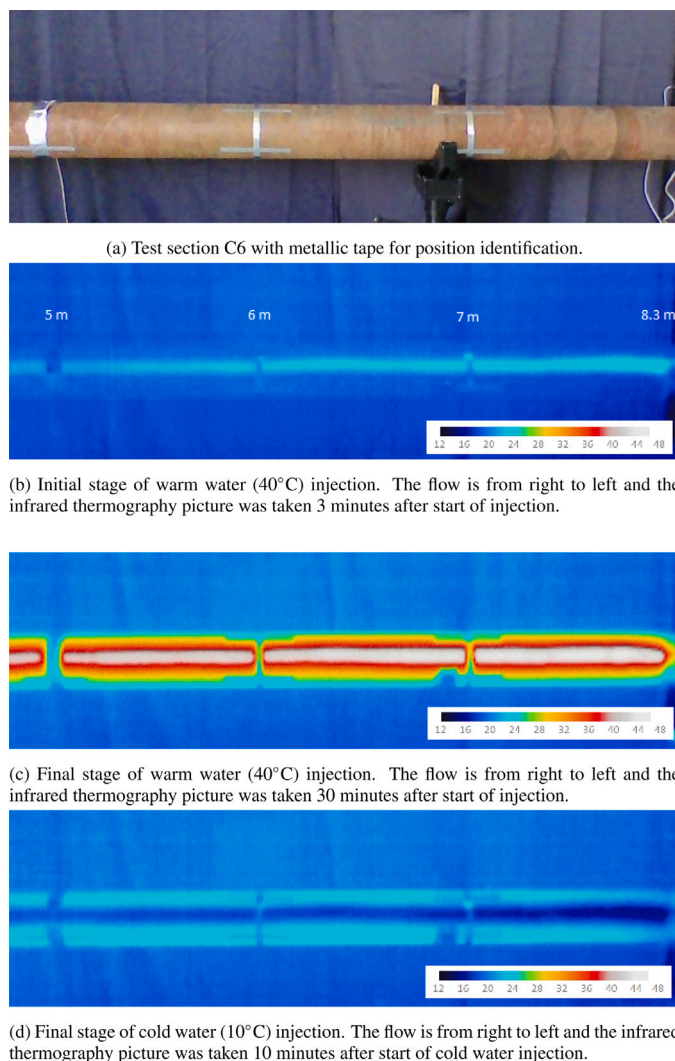
Fig. 5. Sequence of images using infrared thermography during base line flooding test in section C6. The photographs are from the interval between 4.8–8.3 m, at the right end of the assembly. Temperatures are in units of degree Celsius.

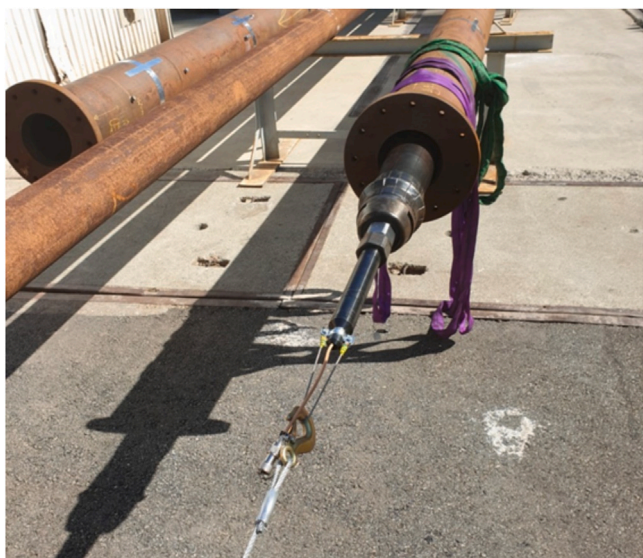
Fig. 7. The casing expansion tool partly inside one of the test assemblies. A dual winch system was used to position the tool inside the assemblies prior to each dent.

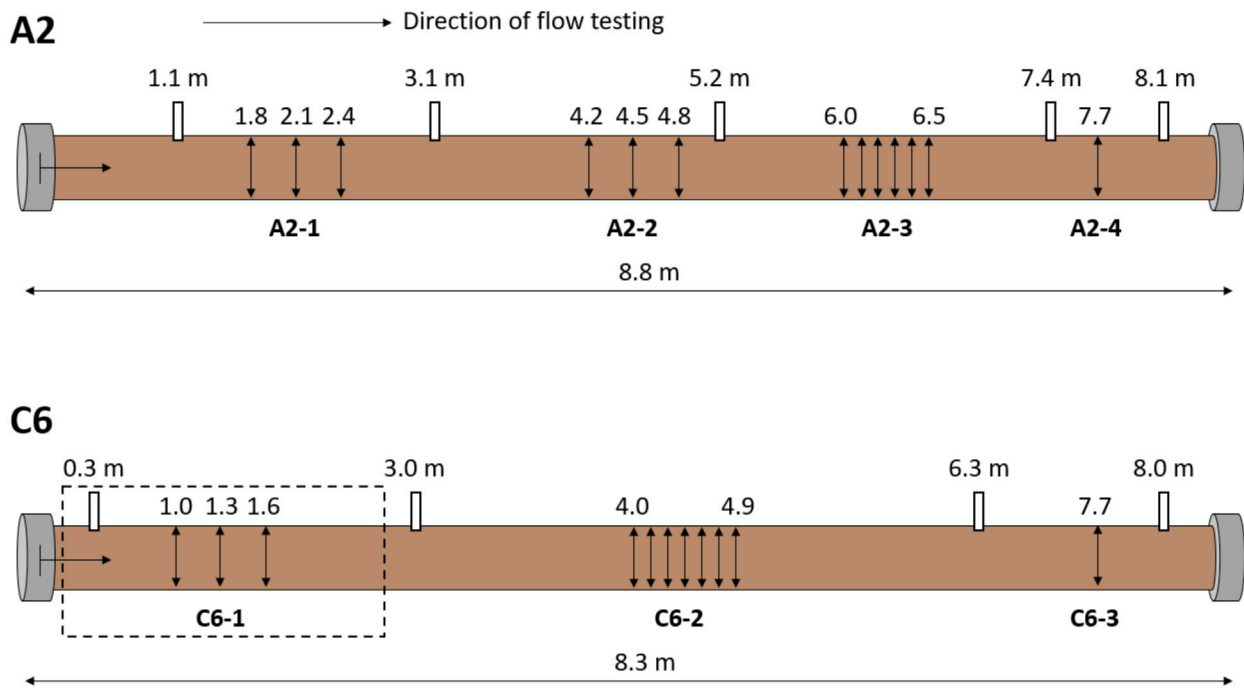
Fig. 8. Configuration of dents and pressure and flow test ports in the two test assemblies. The annular cement at set C6-1 was known to be in very poor initial condition and this segment is indicated by the dashed rectangular box. Assembly A2 and the remainder of C6 had continuous millimeter-sized channels on the top side.

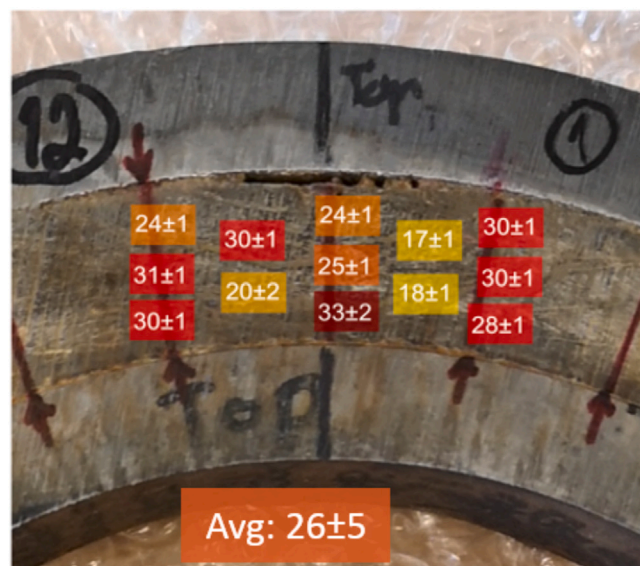
Fig. 12. Results of Vickers hardness testing in the region shown in Fig. 11.

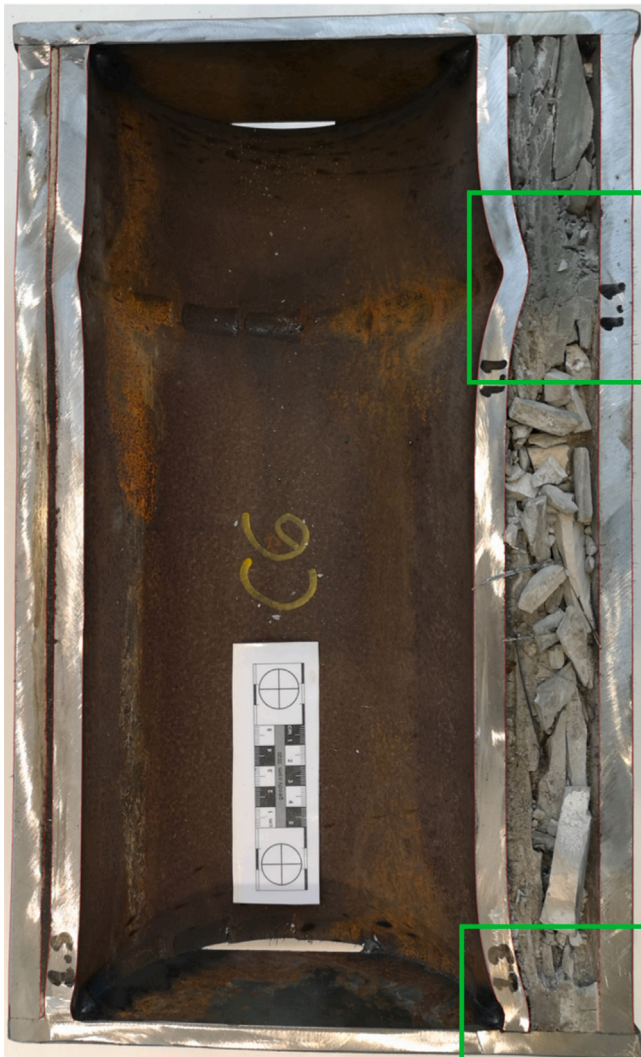
Fig. 18. Axial cross section through the dent at 1.0 m (top-most dent) and one half of the dent at 1.3 m (bottom-most dent). We observe generally fragmented and poor cement away from the dents. At 1.1 m and 1.3 m, the cement appears to have improved cohesion compared to the initial condition seen away from these positions.

Focusing on dents C6-1, set in the poorly cemented part of test assembly C6, the axial view in Fig. 18 reveals the expected very poor and fragmented initial cement condition in this part of assembly C6. However, it is interesting to note what appears to be an improvement in the cement condition at the positions of the two dents in the figure, here indicated by the rectangles, at 1.0 m and 1.3 m from the end of the assembly. Further details can be seen in Fig. 19, where the top panel shows the upper annular cross section at 1.3 m and the bottom panel is

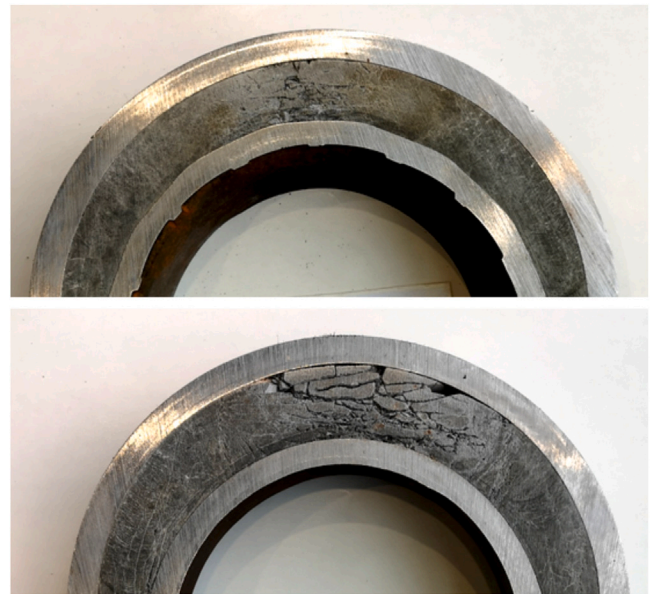
Fig. 19. Cross sectional view of the annular cement at the dent placed at 1.3 m in assembly C6 (top panel) and at 1.35 m, or 5 cm to the right of the dent (bottom panel).

from 1.35 m, or 5 cm to the right of the dent at 1.3 m. The dent in the top panel can clearly be made out by the grooves in the inner tubing wall, resulting from the local, mechanical expansion of the tubing. Although both panels show a heterogeneous and flawed cement, the cement at the dent appears to have better cohesion with less fragments compared to the bottom panel which is the cross-section some 5 cm away from the dent. We recall from Fig. 9 that the compressed cement is not sealing the annular space at this level of casing expansion and cement compression, but it is not unlikely that a greater degree of expansion could potentially have reduced the permeability further. It is worth noting here that the forming limit of the pipe was not reached, *i.e.*, in theory much larger radial expansions are possible and could also be imposed using the newest generation of LCE tools.
